CON-E-CO®

SOLUTIONS

that increase production and reduce costs

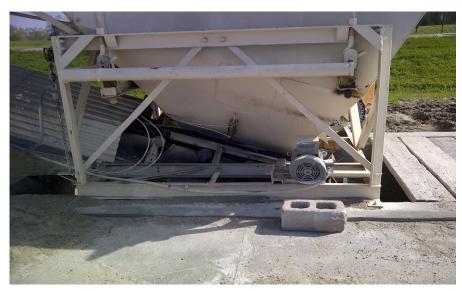
PROBLEM: 8yd³ maximum decumlative aggregate batcher slowed production.

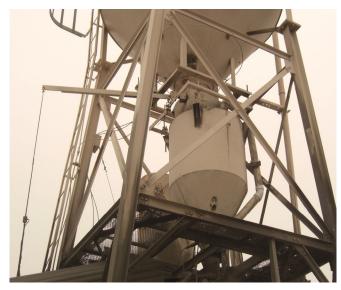
PROBLEM: 5 yd³ cement batcher, double batching slowed production.
